# U.S. DEPARTMENT OF AGRICULTURE

PHOTO SERIES NO. 36

## INSECT CONTROL ON STORED PRODUCTS

APRIL 1959

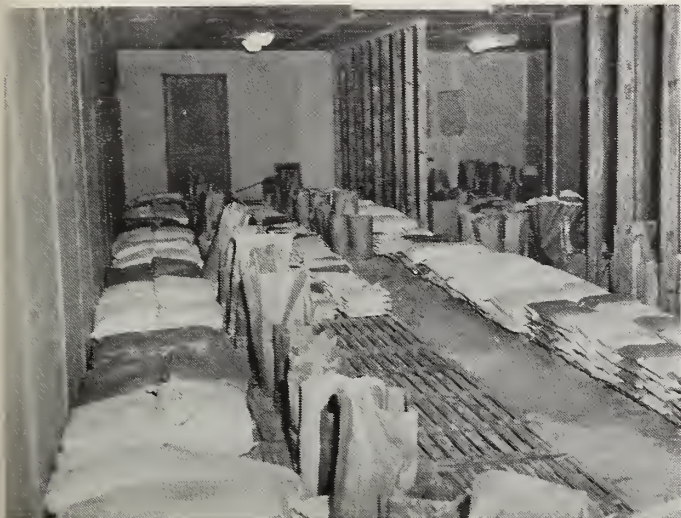
N-26955--A "bugged" room. There are 14 kinds of insects in this room used for exposure of experimentally treated packages. Periodic breakdown inspections of the test packages show the effectiveness of experimental treatments in preventing insect penetration and infestation.

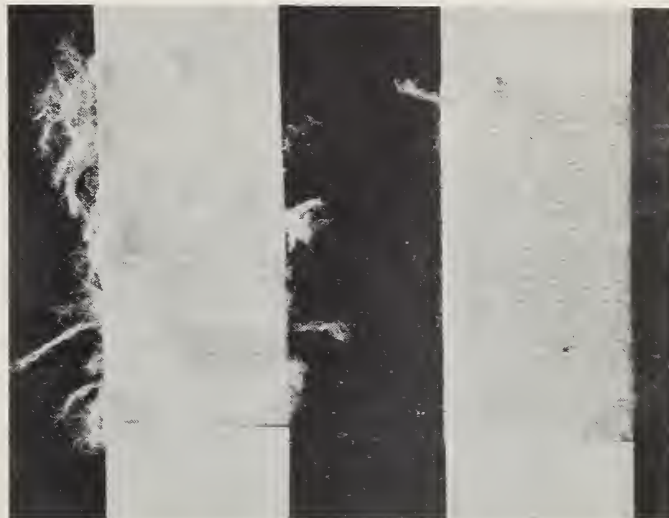
N-26944--Which one has the treatment? Left: Untreated yarn showing damage by black carpet beetle larvae. Right: Yarn treated with DDT during wool scouring. Yarn samples were left in separate petri dishes 28 days, with 10 larvae in each dish.

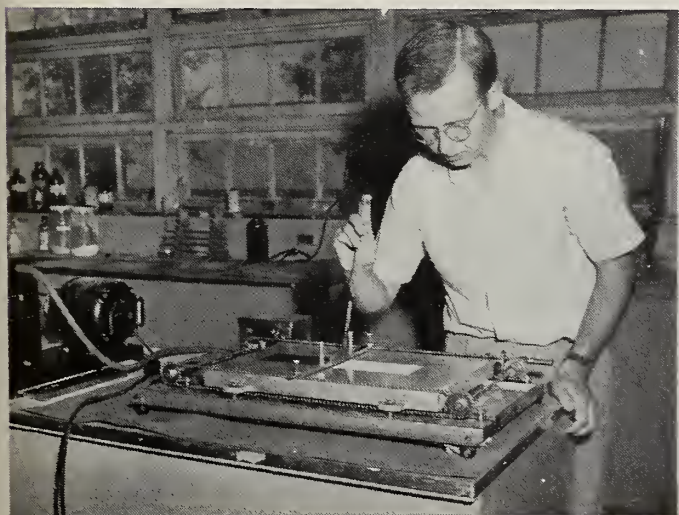
N-26961--An automatic blade applicator applies an even coat of insecticide to paper for testing.

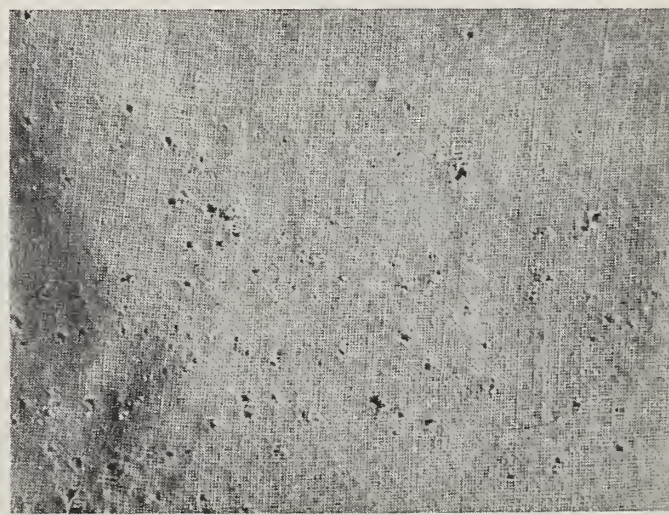
N-26943--Damage done by the lesser grain borer. This insect eats through cloth bags to get at food.

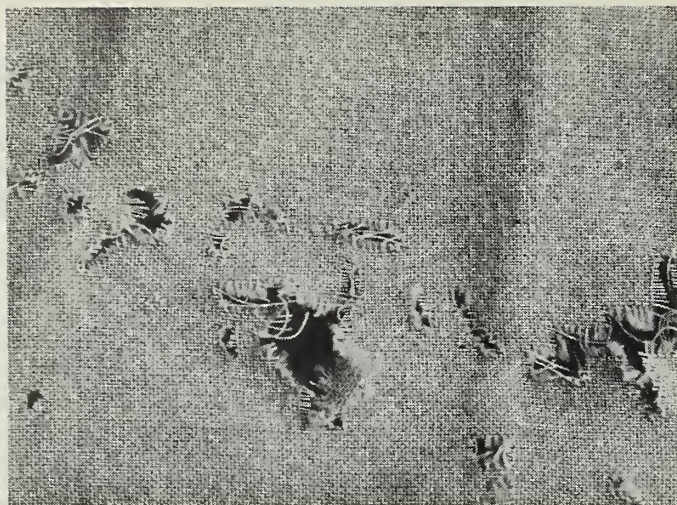
◁ N-26942--Rayon textile feed bag damaged by American roach. A feed company tried using bags made of rayon to attract farm women to buy its products, but roaches attacked the rayon, and the company had to abandon its use.

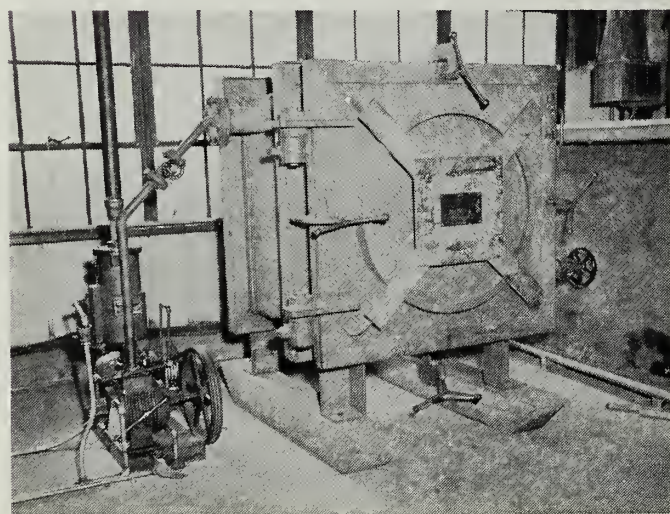
N-26954--Fumigation chamber, vacuum-type, in which scientists test different types of fumigants under controlled conditions. ▷

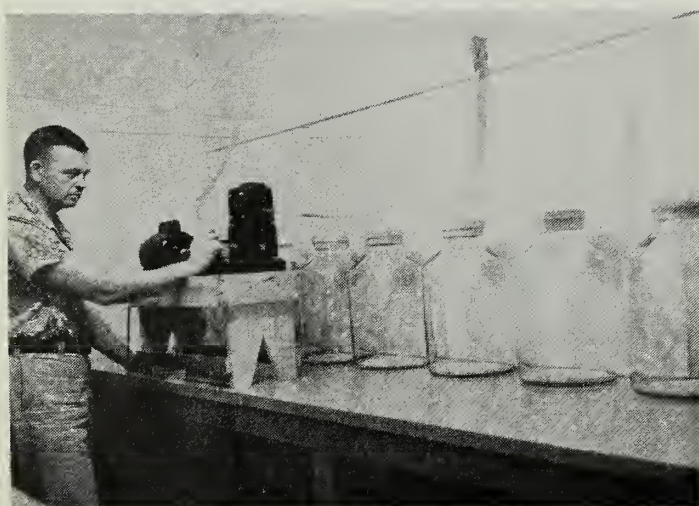
◁ N-26947--R. E. Bry, entomologist, experiments with concentrations of insecticides (here, crystalline lindane). Pump forces vapor into jars in succession. Experiments are being conducted to evaluate the use of lindane crystals as a substitute for naphthalene in protecting boxed Army uniforms.

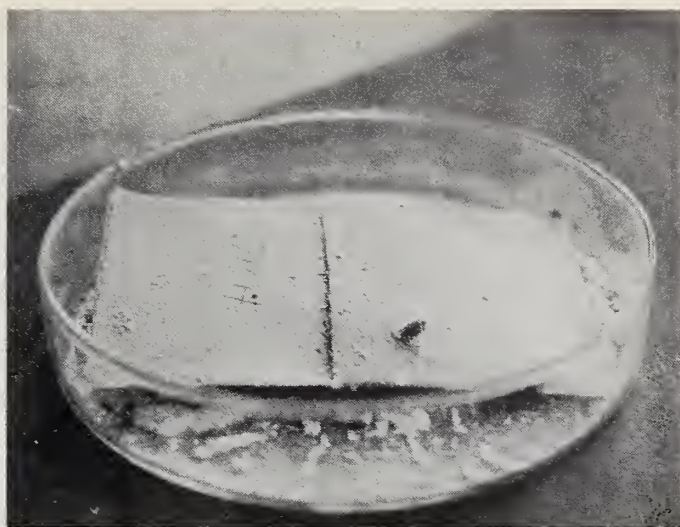
N-26945--Cadelle beetle larva in petri dish caught in the act of penetrating a packet of untreated 50-pound kraft paper--a rare scene.

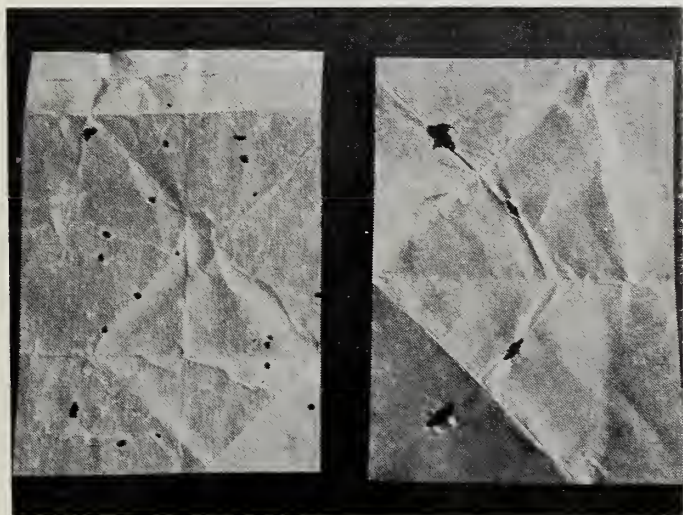
N-26941--Kraft paper after removal from petri dish, showing (left) lesser grain borer penetration; (right) cadelle beetle larval penetrations.

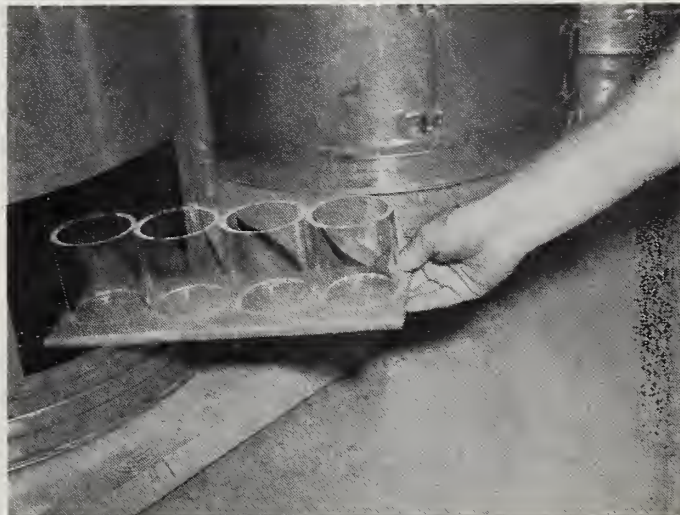
N-26959--Glass cylinders containing insects are placed in settling tower for exposure to insecticide.

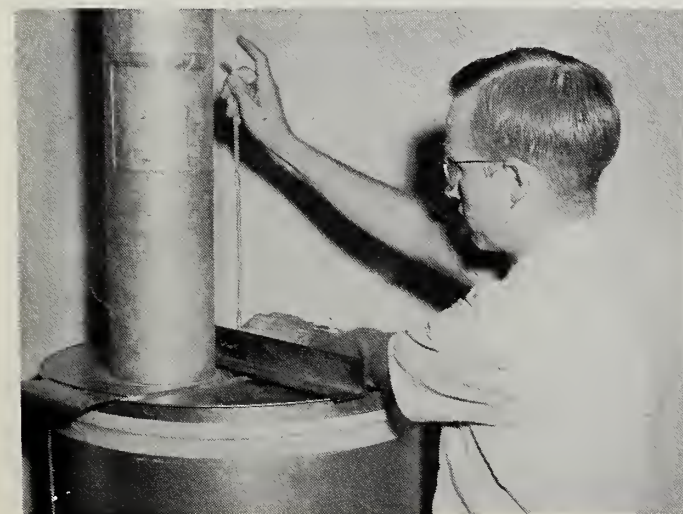
N-26957--Roy Speirs, entomologist, introduces insecticide in top of settling tower.

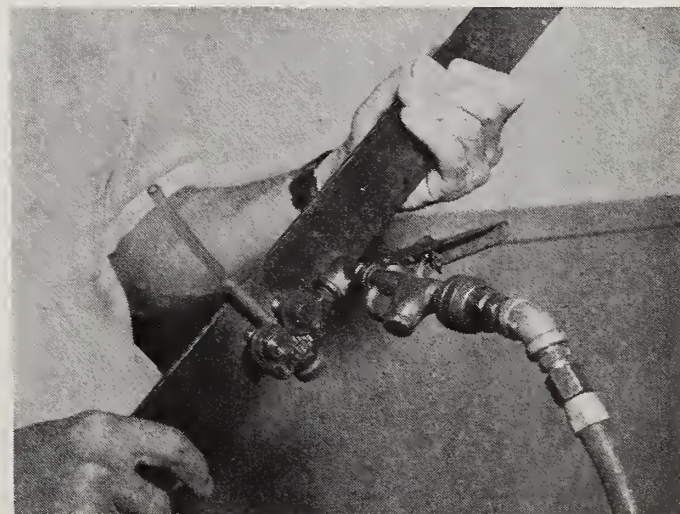
N-26958--Closeup of nozzle used at top of settling tower. Compressed air is employed to introduce insecticide in even amounts.

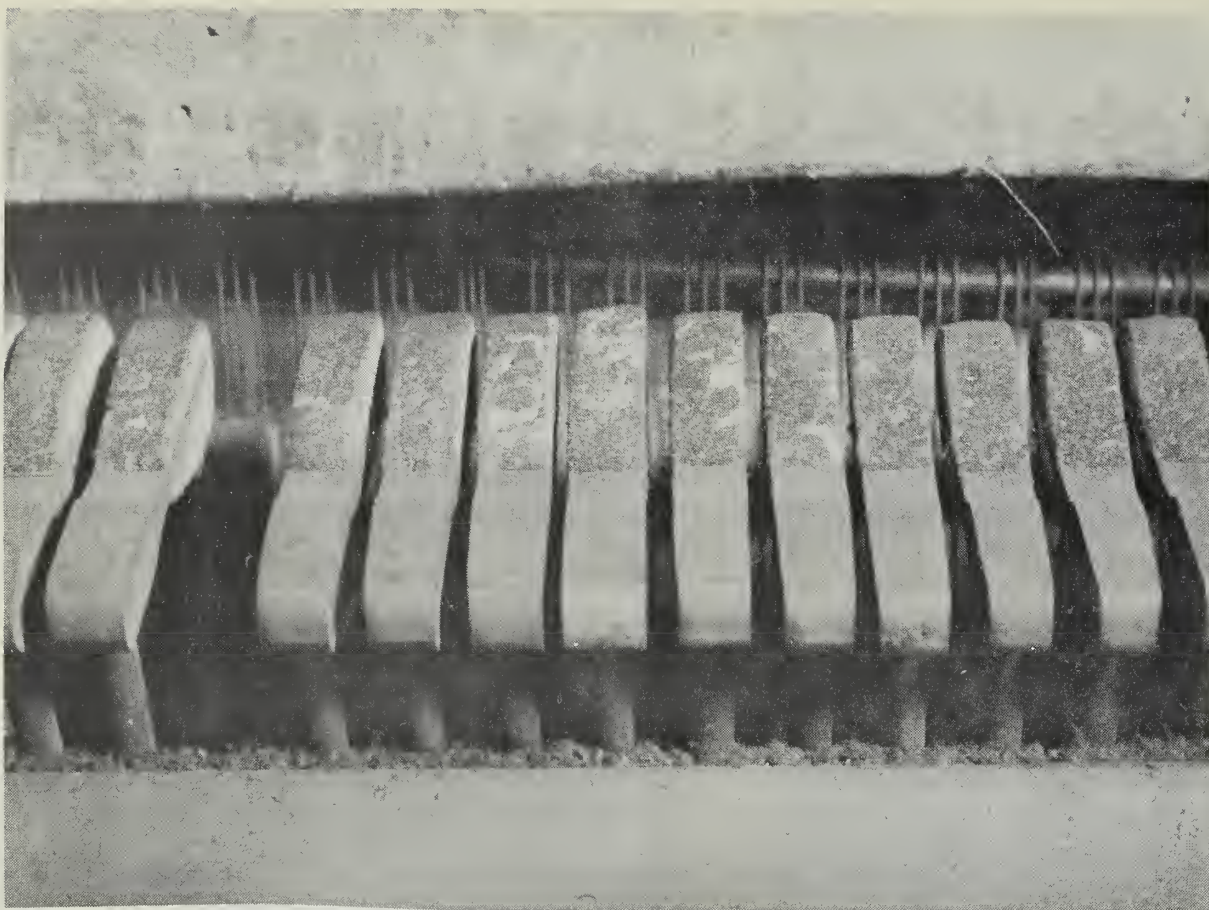
N-26949--Piano hammer heads damaged by carpet beetle larvae. An estimated 77 percent of the pianos in the United States are infested with insects.

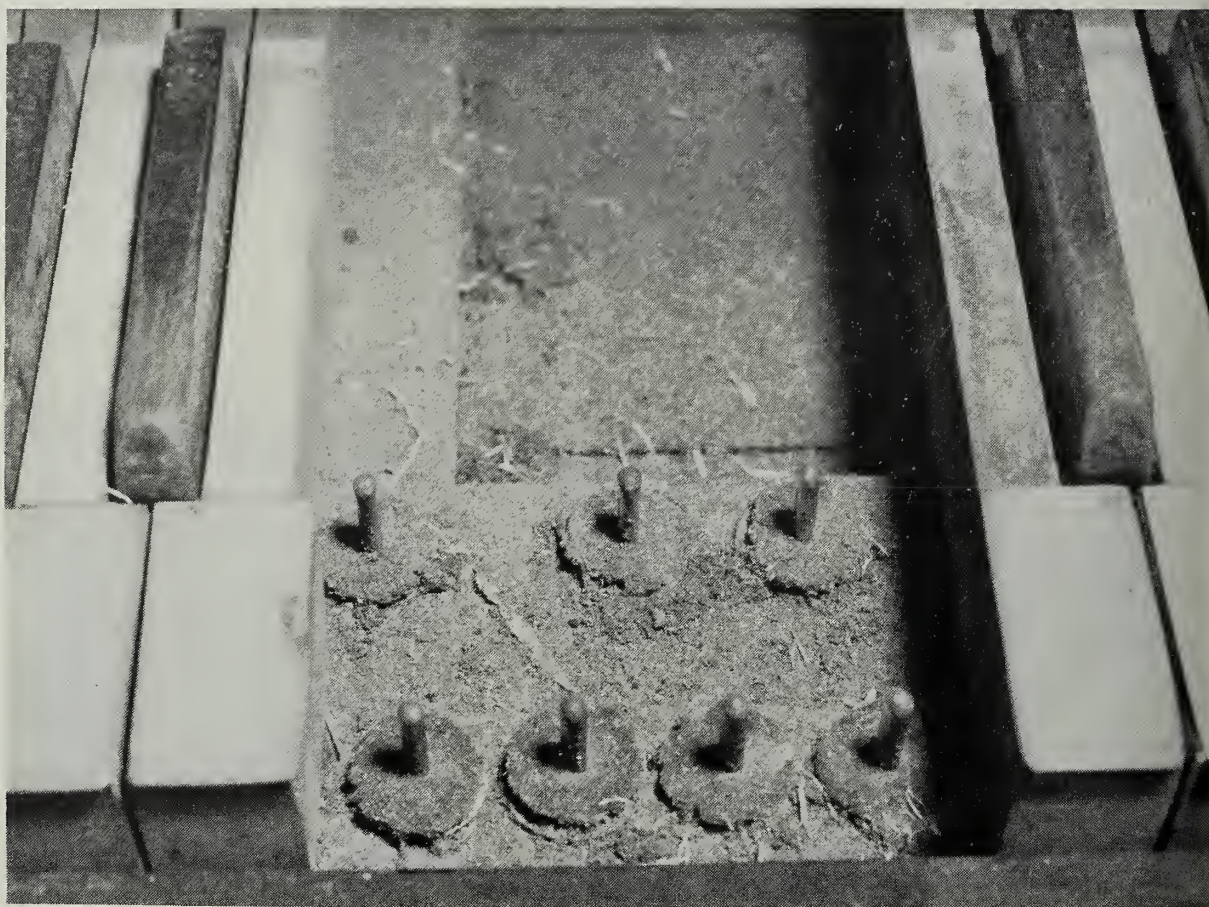
N-26948--Carpet beetles and moths have attacked felt in this section of front rail punchings between keys on old piano.
